PHASE I INSPECTION REPORT
NATIONAL DAM INSPECTION PROGRAM

BRIER CREST WOODS DAM

NDI ID No. PA-00879
DER ID No. 45-245

FEBRUARY 1980

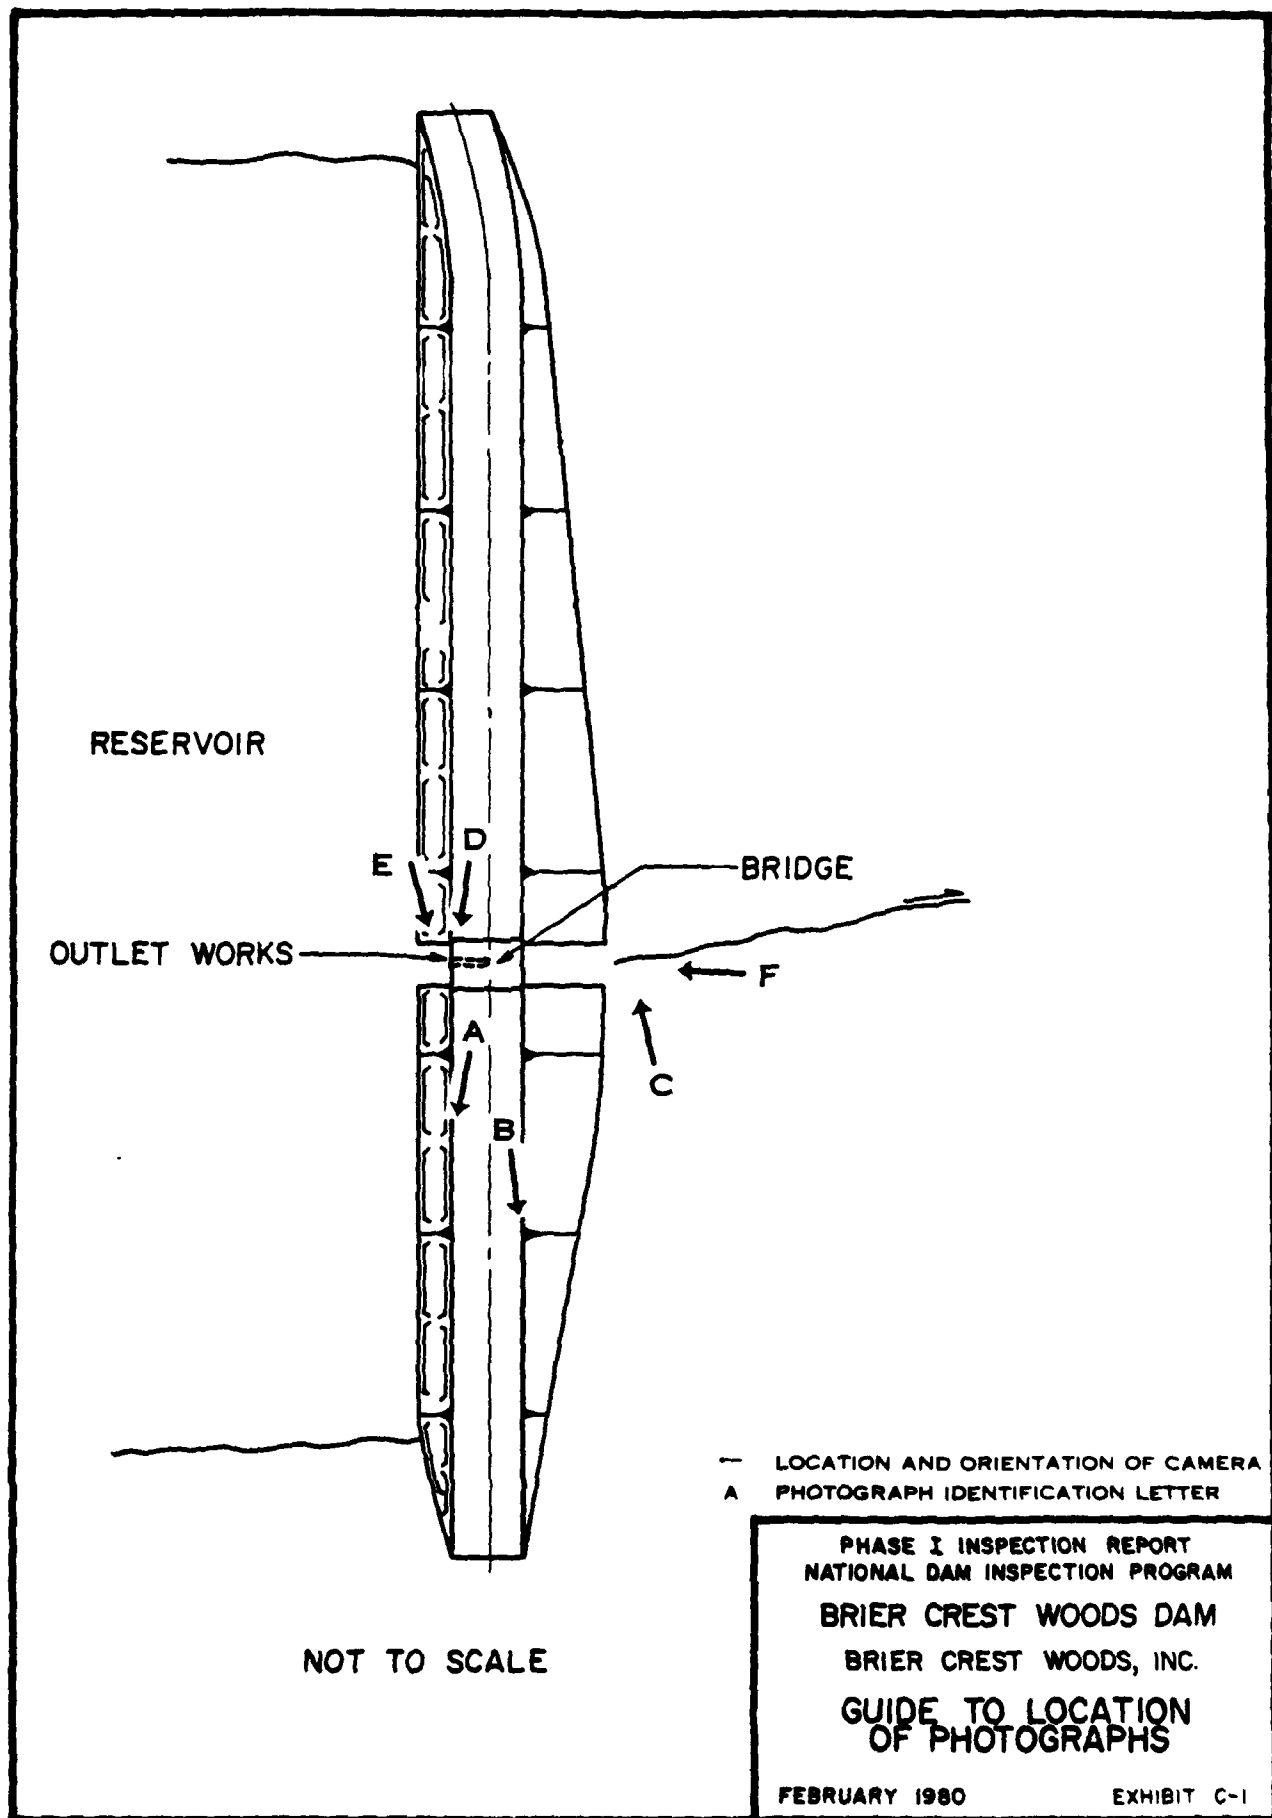
F. Spillway

c. Appurtenant Structures. The spillway is in good condition. No deficiencies were observed at either the weir or the exit channel apron. The sidewalls of the exit channel apron, which also act as the bridge abutments, have a shrinkage crack on each side approximately coincident with the axis of the dam. The weep holes in these walls were trickling (Photograph F). The bridge deck is in good condition.
